A damaged sewer main with the potential to cause severe environmental pollution prompted an emergency callout from Northumbrian Water Group to Selwood's pump rental team to come up with a solution.

The pipe, underneath a car park at Cat Nab, a prominent hill on the seafront at Saltburn, was damaged by a third party working on behalf of the local council.

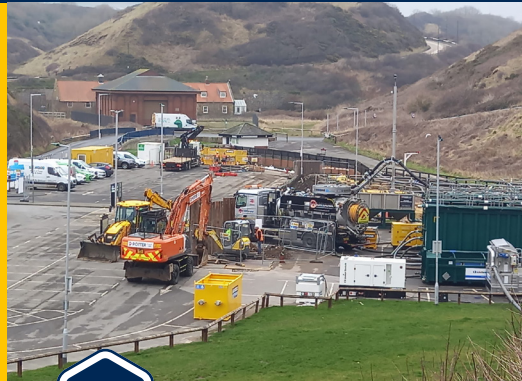
The contents of the pipe began spilling onto the beach, risking pollution of a stream known as Skelton Beck and into the North Sea.

As a short-term measure, tankers were used to transport sewage away and reduce the volume of waste entering the sea.

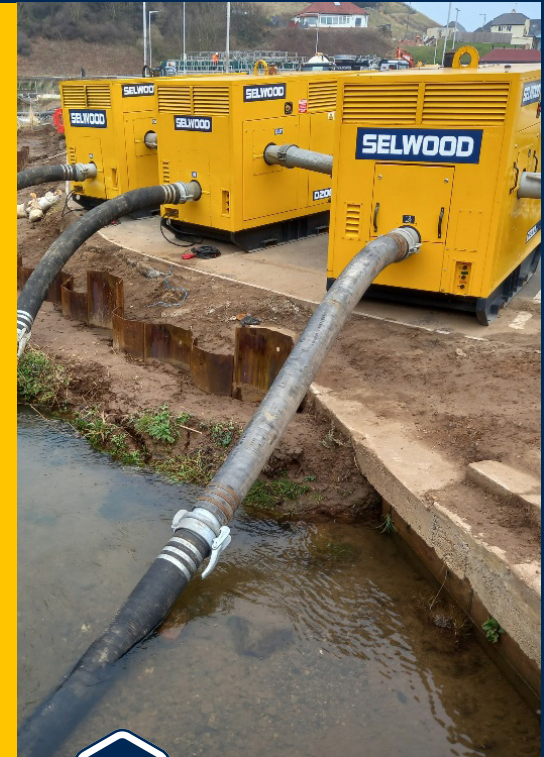
A third solution was to overpump the beck, so the last piece of the puzzle was to produce an over pump system to cover approximately 350l/sec.

The team used three D200 pumps to do this, replacing the oil in the unit with food grade oils to avoid pollution. Purpose-made filter socks were used to meet the requirement from the Environment Agency to stop any aquatic being pushed forward through the pump.
